HONEY LAKE VALLEY RESOURCE CONSERVATION DISTRICT

INFRASTRUCTURE INVENTORY AND CAPITAL IMPROVEMENTS PLAN LASSEN COUNTY, CALIFORNIA JANUARY 2013

DYER ENGINEERING CONSULTANTS, INC.

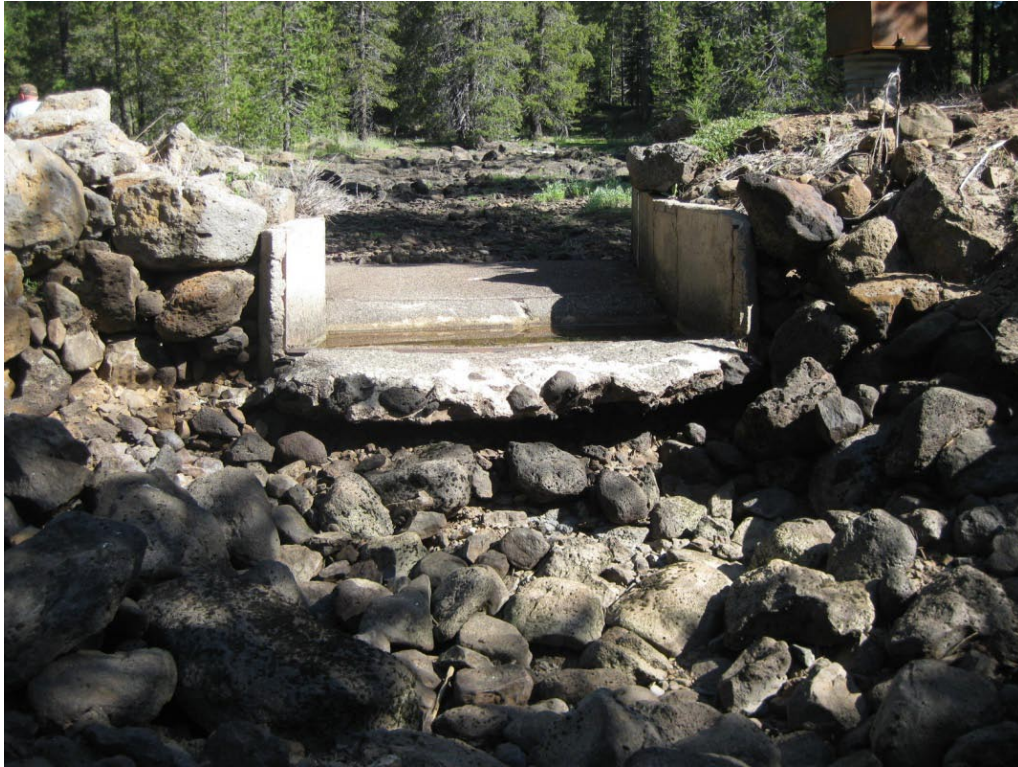
Figure 1: Susan River into McCoy Flat Reservoir

The second improvement is channel rehabilitation. Due to the nature of high flows, river water is split approximately 100 feet above the existing structure into three channels. Two of the channels join together 20 feet in front of the existing flume, but the third channel circumvents the entire structure, flows through an adjacent meadow, and then into the reservoir. For better flow measurement, this third channel should be blocked using a dike with engineered soil to provide an embankment that will keep the flows within the Susan River channel. The engineer's estimate for this project is \$32,000. Channel rehabilitation costs were not analyzed at this time.

The improvements to this structure are two-fold. The first improvement is to demolish the existing structure and replace it with a broad crested weir with a low flow channel. The broad crested weir will have an increased length of 12 feet which will increase the current measurement capacity from 139.5 cfs to approximately 215 cfs. Additionally, it is recommended that a larger apron be poured on both the inlet and outlet sides of the weir. A stilling basin with pressure sensors should be installed and connected to a radio SCADA unit for remote measurement. The outlet side of the weir should be ramped down to the existing channel bottom with energy dissipaters installed to reduce erosion. Wing walls should extend at least 30 feet from either side of the inlet in order to better capture flows from the Susan River Channel. A cutoff wall of at least 4 feet should be poured under the weir to limit seepage and undercutting.

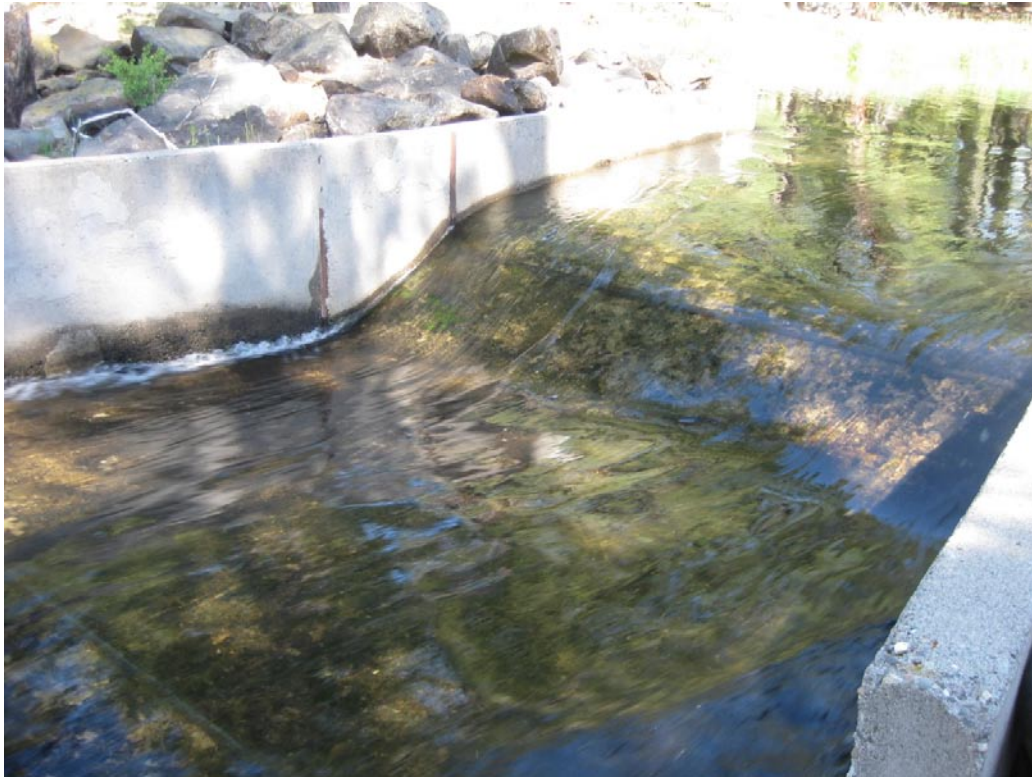
Figure 3: McCoy Flat Outlet 12' Parshall Flume

Flows out of McCoy Flat Reservoir are measured in a 12 foot Parshall flume. The flume appears to have been built in 1954 from a date stamped into one of the wing walls. While flows can be measured fairly accurately, this flume has settled over the years on the eastern side resulting in an uneven throat. Additionally, the concrete of the flume is cracked, scaled, and showing signs of freeze-thaw failure with exposed aggregate present throughout. Rebar has been exposed in the throat and diverging section. The upstream wing walls are undersized and as a result, side cutting and seepage is occurring throughout the structure. There does not appear to be any evidence of submergence or overtopping of the bank at this structure.

This structure should be replaced with a new 12 foot Parshall flume. The new structure should have enlarged wing walls on both the upstream and downstream side, extending the wing walls an additional 10 feet should limit the side cutting, while a small cut off wall should be installed on the upstream ramp to prevent seepage under the new structure. The existing stilling well should be retrofitted to accept a SCADA radio system to allow remote monitoring for better flood management and dam management. The engineer's estimate for this project is \$59,000.

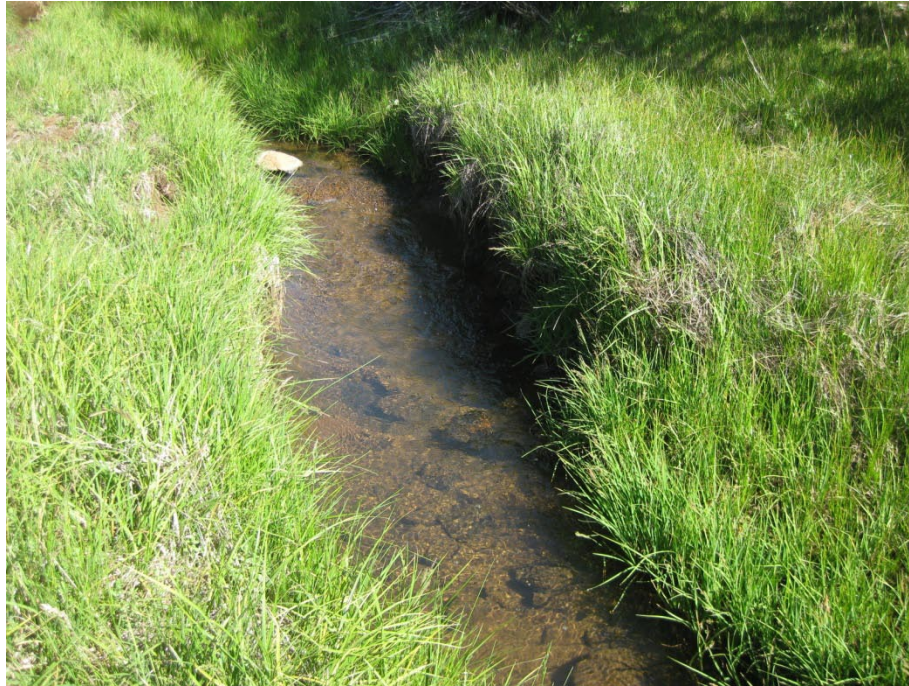
Figure 4: Bridge Creek

Bridge Creek is a perennial seep fed stream that flows into McCoy Flat Reservoir and is a secondary source of surface water utilized for storage. There is an existing USGS gauge station that appears to have been abandoned having been washed out in past high water events. For water reporting and planning purposes, it is important to measure flows into McCoy Flat Reservoir. The recommended action is to install a 9 inch steel Parshall flume. Flow measurement will be recorded in a stilling basin fitted with pressure transducers connected to a radio controlled SCADA unit for remote monitoring. The engineer's estimate for this project is \$9,000.

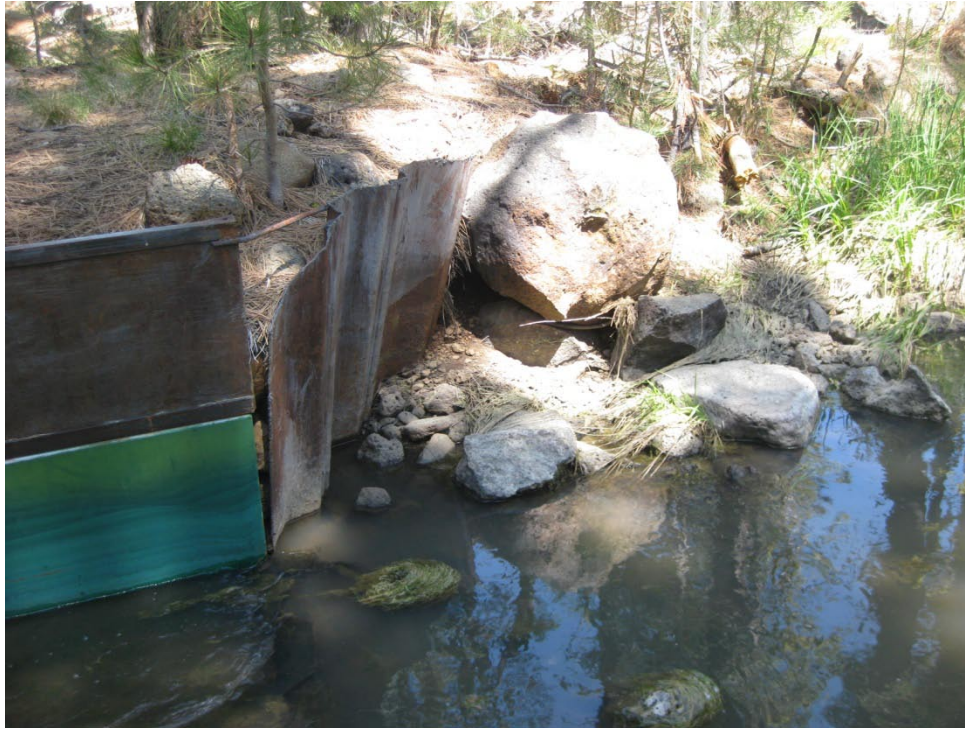
Figure 5: Parshall Flume at Hog Flat Reservoir

The existing flow measurement at Hog Flat Reservoir is an 8 foot steel Parshall. The measurement structure is undersized, bent, and not level. When originally constructed, the steel stabilizing bars were not installed in the structure resulting in the soil pressure collapsing the top of the throat walls. The existing wing walls are corrugated steel pilings that are no longer flush with the structure allowing for side cutting and flows escaping the converging section. The existing structure was also set at an elevation that was too low, resulting in submergence in moderate flows rendering the functionality of the structure obsolete. The flows released from Hog Flat Reservoir exceed the capacity of the current structure during high release events. To correct these problems, it is recommended that a new 10 foot concrete Parshall flume be installed in the current location. Concrete wing walls shall be installed on all four corners extending an additional 15 feet to facilitate flow capture and limit side cutting of the bank. Limited grading is expected due to the existing topography immediately adjacent to the structure. A stilling basin fitted with pressure transducers connected to a radio SCADA unit should be installed to allow for remote measurement and data collection. The cost to replace the existing steel structure with a poured in place concrete Parshall will be approximately \$59,000 dollars.

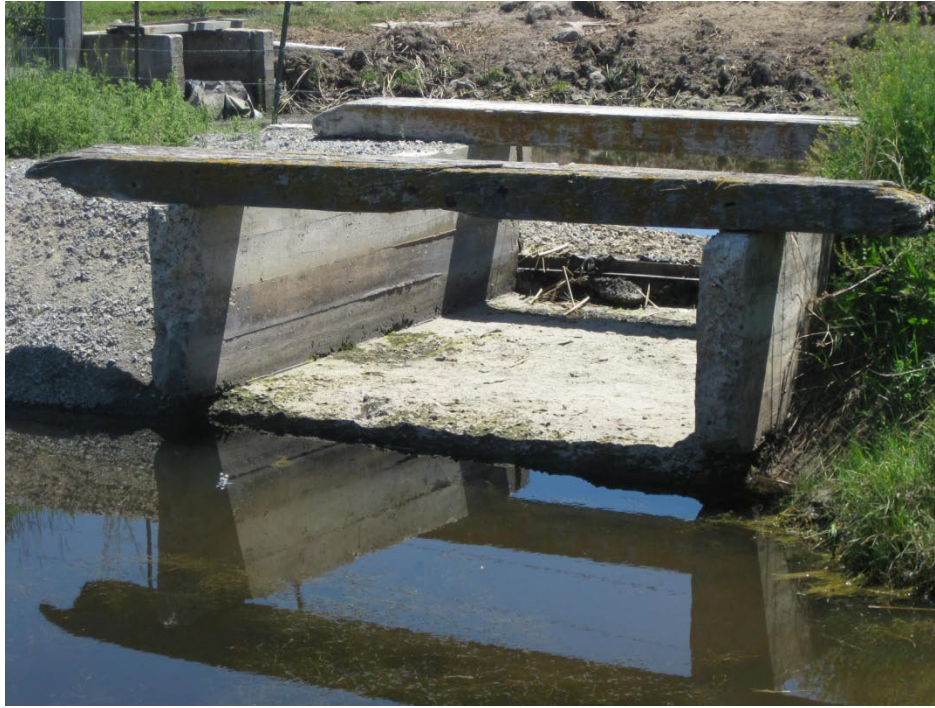
Figure 6: 100 Inch Weir on Willow Creek

The 100 Inch Weir is used to split flows from Willow Creek for stock watering and agricultural use as well as water measurement for the Department of Fish and Game. Willow Creek is diverted upstream into a canal for a short run before being returned to its natural channel through the weir. The current structure is a concrete weir with slots for flash boards for flow control. Flow is measured over the tops of the boards manually by the water master. The current orientation of weir and flashboards first then a spillway make flow measurement difficult in high water flows. The concrete is cracked, scaling, with large pieces missing from the head and wing walls resulting in exposed rebar. Erosion is evident on the creek side of the structure from high flows and an absence of wing walls. The engineer's recommendation calls for the replacement of the structure as well as the addition of wing walls on the downstream channel section. The new structure shall reverse the orientation of the weir and apron as well to facilitate flow measurement. Flash boards shall still be used due to the varied nature of flows and quality of water rights. To facilitate management, a locking system shall be installed as well so the water master can set flow limits. A monitoring well fitted with pressure sensors shall be added to the new structure and connected to a radio SCADA unit for remote flow monitoring. The engineer's estimate for this project is \$54,000.

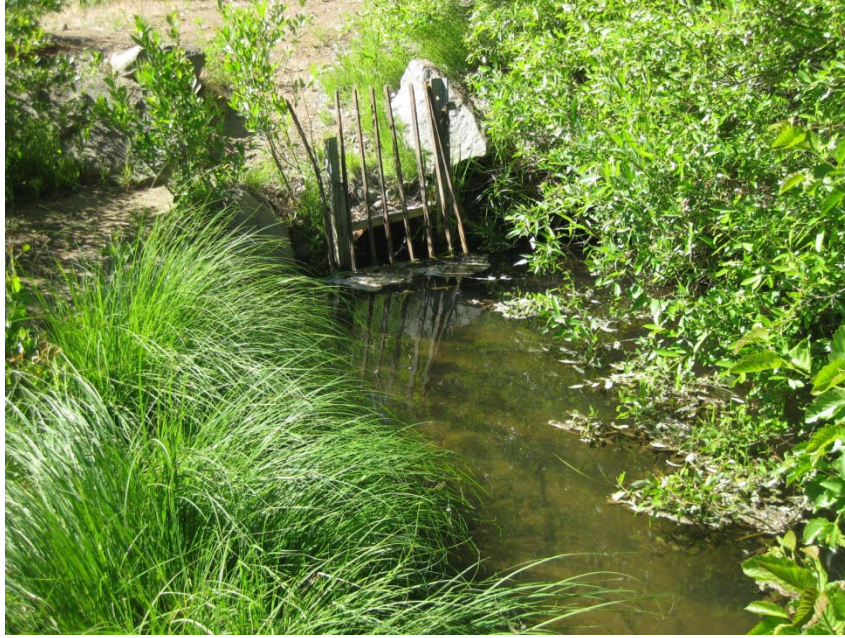
Figure 7: Ramsey's Ditch Intake

Ramsey's diversion and ditch diversion is a low-head, sand bag diversion and water conveyance ditch located adjacent to Hobo Camp on the Susan River. This diversion is used to convey water from the Susan River into the Ramsey's ditch for on river water users. The existing diversion is approximately 30 feet of sandbags and a small channel dredged to a CMP outfitted with trash screen and head gate that provide flows into Ramsey's ditch. The current head gate structure is bent, and the concrete is cracked, exposed aggregate, and scaling. The required flows amount to 5 cfs during peak demand, but only 3 cfs is currently being delivered. This flow schedule was obtained through empirical evidence and data as existing flow measurement is not possible at this location. The engineer's recommendation includes replacing the existing damaged gate and concrete structure with a new head wall and a new 24 inch by 24 inch head gate. The channel from the river to the ditch should be slightly enlarged to accommodate more flows. Downstream of the new head gate, an existing 12 inch concrete Parshall flume shall be retrofitted with a stilling basin outfitted with pressure transducers and connected to a radio controlled SCADA unit for remote flow measurement. The new gate shall be provided with flow rating curves to facilitate flow delivery. Ramsey's Diversion is a critical project for flow measurement, because this is the first diversion down-stream of the reservoirs and the first place where water is taken from the Susan River for individual use. The engineer's estimate for this project is \$18,000.

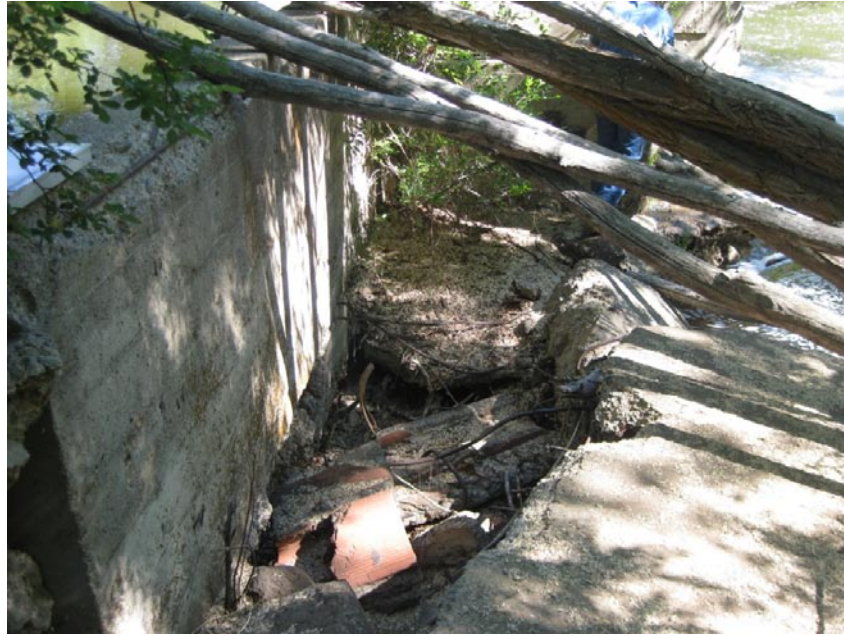
Figure 8: Mill Diversion

The Mill Diversion is a buttress dam that was previously used for diverting water to the mill pond and lumber yard owned and operated by Sierra Pacific Power Company. The current structure has been removed from service and no longer serves as a beneficial use structure. There are plans to create a white water park through the City of Susanville that require the removal of this structure and regrading of the river channel and bank. This structure has collapsed sections, leaking gates, exposed rebar, and failing concrete. In the current condition, this structure is a safety hazard and should be removed. Removal of this structure should be done in conjunction with construction of the white water park, as the existing channel has a large drop (approximately 6 feet) that will need to be re-graded to prevent further down cutting and erosion. The cost to only remove the structure would be approximately \$15,000. Channel rehab and preparation for a white water park are costs that could not be analyzed at this time.

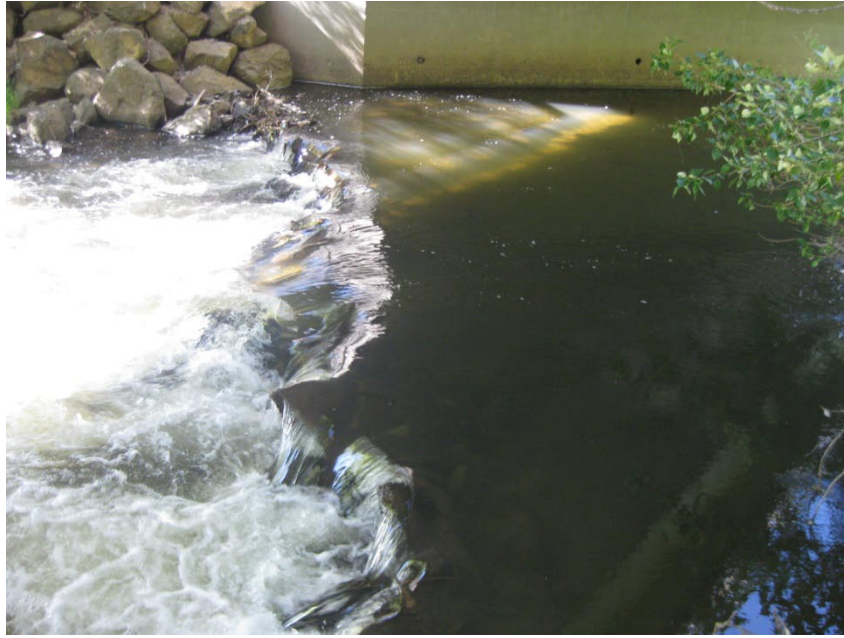
Figure 9: Susan River at Lassen Creek Street Bridge

The Susan River first enters into Susanville at Lassen Creek Road. At this crossing, there is a bridge with a rated section used to estimate river flows. This is the first measurement device on the Susan River downstream of Hog and McCoy Flat Reservoir. Currently, the bridge abutments serve as the rated section while a stilling well and staff gage are used to record flows. Under the bridge, the channel is of natural construction. Natural stream beds are not conducive for flow measurement as they are not a uniform section and change frequently in form. This was evident during the site visit in which debris was observed under the bridge being caught and held in place by boulders and other obstacles sitting on the channel bottom. The existing wing walls are properly sized for this structure as limited side cutting evidence was found during field investigations. To remedy this, a concrete apron 30 feet wide by 50 feet long and 6 inches in depth shall be poured between the existing concrete bridge supports. The existing stilling well shall be retrofitted with pressure transducers and a radio connected SCADA unit for remote monitoring. This structure is critical for flood control in Susanville as it serves as the first river measurement device downstream of Hog and McCoy Flat Reservoirs. Measuring flow during storm events at this point on the river will allow for better reservoir management, and better downstream management of gates and dams. The estimate cost to pour a concrete bottom within the bridge supports and retrofit the stilling basin with SCADA units is \$34,000.00.

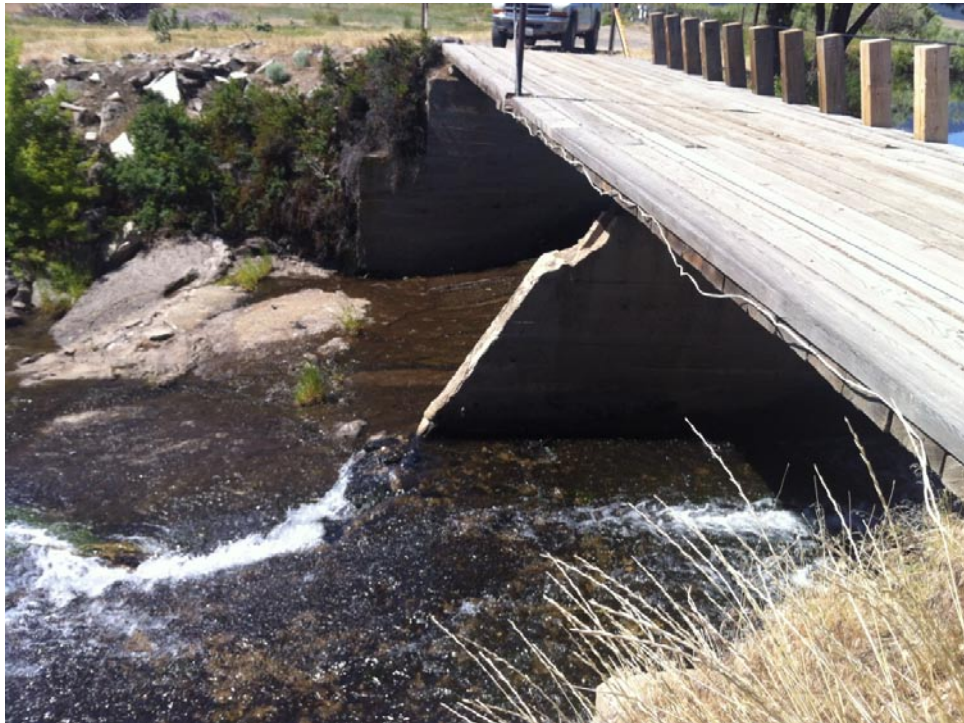
Figure 10: Johnstonville Dam

Johnstonville Dam is also a dam of high concern given the nature of flows experienced. During the high water event of 2011, the deck of the Johnstonville Dam was moved 6 inches by the hydrostatic forces present on the uprights and flashboards. This dam is not safely managed in high water situations given the design of the uprights and the 15 feet of head against the flashboards. In every emergency situation, flashboards and in some cases uprights are blown out to try and relieve pressure on the dam. The restoration of this dam would allow for the capture of flood waters for irrigation use rather than losing them to Honey Lake.

The existing structure is in ill repair. The end support structures are cracked and pitted while the middle buttress has a large piece missing at the point of connection with the deck, exposing a lack of rebar. There was no evidence of side cutting along the wing walls, but there are boils downstream of the structure proving that undercutting of the dam is an issue. The existing flashboards are old, many of them cracked and leaking profusely at the bottom of the dam. DEC recommends that this dam be replaced in its entirety. The proposed dam would be a buttress style dam with radial gates installed in lieu of flashboards and uprights. A stilling well with pressure transducers should be installed and coupled with a radio SCADA unit. The radial gates should be actuated and controlled with the same SCADA unit. Changing this dam to a bottom opening structure will require a larger spillway with energy dissipaters but will provide better flood control and a safer working environment for the water masters. Remote access will allow for dam management in large events when overtopping of the dam is a possibility, as has happened in flood events in the 1980s and 1990s as reported by the NRCS. The preliminary cost to replace this dam would be approximately \$950,000, which is subject to change pending future hydrologic and geotechnical analysis.

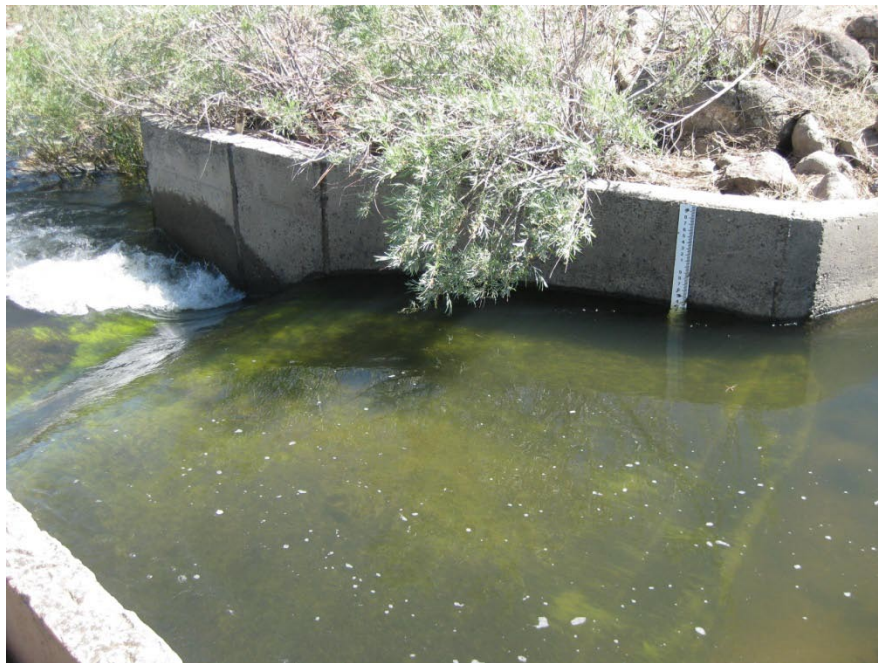
Figure 11: Buffum Parshall

Buffum Parshall is located on the AB canal just upstream from Leavitt Lake. Buffum is used to measure flows in the canal prior to entering Leavitt Lake. This Parshall flume is an 8 foot style flume. The structure is in good repair but three deficiencies were identified by DEC during field investigations. First, the flume is set too low within the channel resulting in submergence during high flows. Parshall flumes of this size can only handle a max flow of 139.5 cfs before submergence corrections need to be applied. The max flow of the AB canal is 200 cfs. While there are two upstream water users, their rights do not draw 60 cfs from the canal. Coupled with the flow line being set too low in the channel, Buffum is regularly rendered unusable due to higher flows. The second issue with Buffum Parshall is bank and channel stability. The AB canal has been subject to years of down cutting and the current structure sits approximately 15 feet below the channel top, with nearly vertical side slopes that continually erode into the channel. The third deficiency found on the flume is the flow measurement device has not been calibrated to read correctly. To rectify this problem, DEC recommends a rebuild of the Parshall flume coupled with laying back the streams banks at a 3:1 slope. The new flume shall be a 12 foot flume, capable of handling flows of 350 cfs before submergence. The flume shall be installed with a stilling well outfitted with pressure transducers which will be connected to a radio SCADA unit allowing for remote measurement. The banks extending 50 feet upstream and 50 feet downstream shall be laid back at a 3:1 slope and then reinforced with rock rip rap. This will prevent further erosion and sloughing into the canal. The engineers estimate to complete this project is \$71,000.

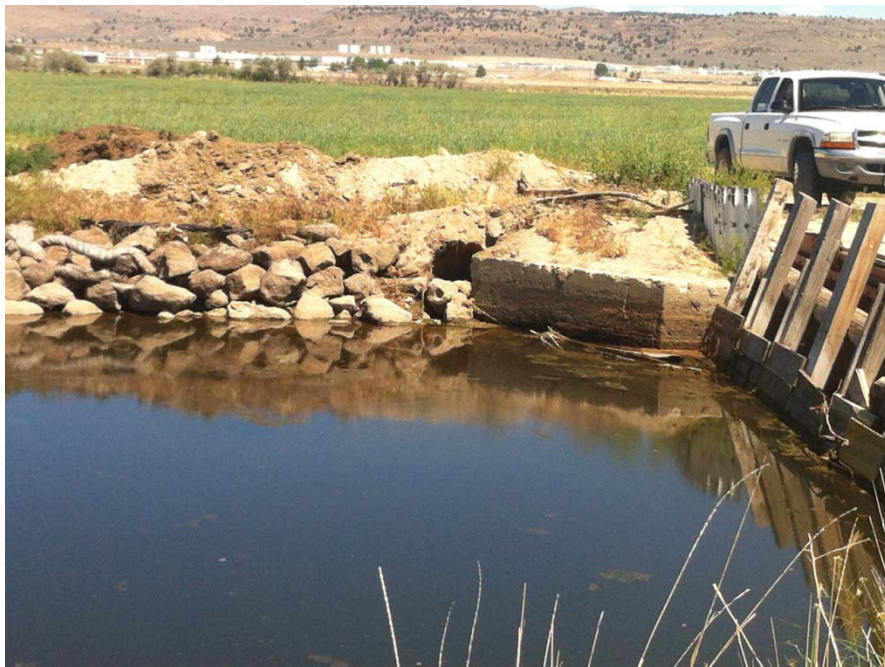
Figure 12: Toscani Dam

Toscani Dam is located on the Susan River and is the boundary of Schedule 5 priority 2 flows. Thus, flows at this structure are used to determine downstream water appropriations. The existing dam is comprised of two upright concrete structures on which a 40 foot by 12 foot rail car bed is laid. The uprights are driven into the channel bottom and rest against this rail car. Flashboards are used to control the flow and concrete wing walls direct flows to a 36 inch CMP culvert. During field analysis, concrete flaws were observed on the dam as well as other flow problems. The concrete of the wing walls and end buttresses was in fair condition. Boils around the end of the concrete apron and as far away as 20 feet from the dam face were recorded by DEC. Leaking around the wing walls and through the flashboards was noted. No flow measurement was currently observed at this structure. DEC recommends that this dam be retrofitted with a new cutoff wall extended deeper into the substrate, buttresses poured within the channel fitted with radial gates, and flow measurement added. Radial gates are recommended because of the volume of water stored within this section and as a means to effectively manage high water flows during storm and spring runoff events. The radial gates can also be rated for flow for ease of management. The dam shall be installed with a stilling well outfitted with pressure transducers which will be connected to a radio SCADA unit allowing for remote measurement. The radial gates can also be actuated for remote management if so desired. Without actuating the radial gates, the Engineers estimate for this project is \$750,000 which is subject to change pending future hydrologic and geotechnical analysis.

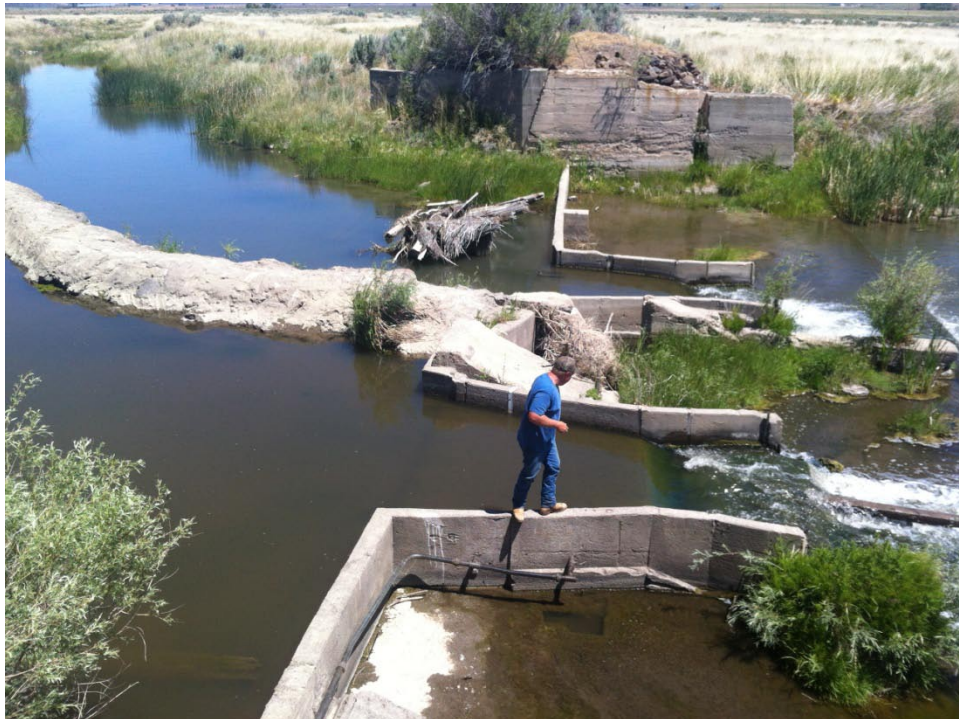
Figure 13: Colony Dam Parshalls

Other dams in the system, such as Window Dam and Colony Dam are non functional (Window) or missing (Colony) and currently have little or no beneficial purpose. Colony Dam's measurement structures leak and are in bad repair. Colony Dam is integral in determining when water can be taken from the Susan River and stored in Lake Leavitt as well as historically storing water within the river channel.

Colony Dam is located at the confluence of Willow Creek and the Susan River. This structure historically had been used as a means to store water (up to 600 acre feet) as well as a measurement of river and creek flows. This is a critical structure for both RCD and LIC for water management. Per *The Susan River Decree*, when flows in the Susan River exceeded 20 cfs during the period of March 1 to July 1 and when in excess of 5 cfs at all other times, water could be diverted into Leavitt Lake at Johnstonville Dam for storage purposes. The existing structure is two 8 foot Parshall flumes, one on each channel, and a concrete dike that separates the Susan River from Willow Creek. The original dam is no longer functioning, as the bridge deck, uprights, and center buttress are not present; it is believed to have washed out during flooding periods. The existing flumes are both showing signs of scaling, exposed rebar, cracked concrete, and sever leakage along the wing walls, head walls, and within the Parshall itself. Boils are evident along the entire length of both flumes with large volumes of backwater present on both flume faces. During high flows, the Parshall flume on the Susan River submerges from being undersized. Additionally, the concrete dike is leaking in multiple locations, allowing the comingling of river and creek flows above the measurement devices. Three actions are recommended by DEC for these existing structures. First, the concrete dike shall be restored to prevent leaking and seepage. The dike shall be retrofitted with new concrete and the cut off wall shall be expanded to limit leakage and seepage. The existing Parshall flumes shall be retrofitted with new concrete. The Susan River Parshall flume shall be enlarged to a 10 foot Parshall flume to handle higher flows during flooding events. Both flumes shall be outfitted with radio SCADA units to allow for remote monitoring and measurement by the RCD water master. Colony Dam itself was originally incorporated into the flume structures and utilized a staff gauge during high water to measure flows. During low water periods, the uprights were removed and the flumes were used for water measurement. The nature of this construction was to store flows in both the Willow Creek and Susan River Channels. By doing so, accurate flow measurement of the Susan River for diversion purposes was not possible. Additionally, combining the flows for storage did not allow for Willow Creek measurement during water storage periods. Colony Dam shall be relocated approximately 50 feet upstream of the current location. Doing this will allow for measurement of Willow Creek during water storing periods as well as no longer comingling of river and creek flows. Moving the dam upstream will create more permitting needs but will result in a simpler design. By keeping the dam in its current location, results in an increase in dike size to keep flows separate and measurable. The current location results in a span about twice as wide as moving the dam upstream to be located solely in the Susan River Channel. Also, Reinstalling Colony Dam will render the Parshall flume downstream redundant. DEC recommends keeping the measurement flumes in the same location though due to ease of access and manual measurement for the water master. Additionally, by replacing the existing Parshall flumes, Susan River water management will not be reliant on Colony Dam being reconstructed.

Should HLVRCD and LIC chose to reconstruct Colony Dam the primary benefit would be an increase in river storage and management of flood conditions, resulting in an approximate addition of 600 Ac-ft of water storage; dependent of future hydrologic and channel analysis. The cost to rehabilitate the Colony Dam Parshalls and dike will be approximately \$179,000. The cost to rehabilitate the Colony Dam will be approximately \$500,000 to \$1,200,000 depending on whether or not the dam was use for storage again and returned to original height (like it was originally intended), but shall be subject to change following further hydraulic and geotechnical analysis and verification of channel capacity.

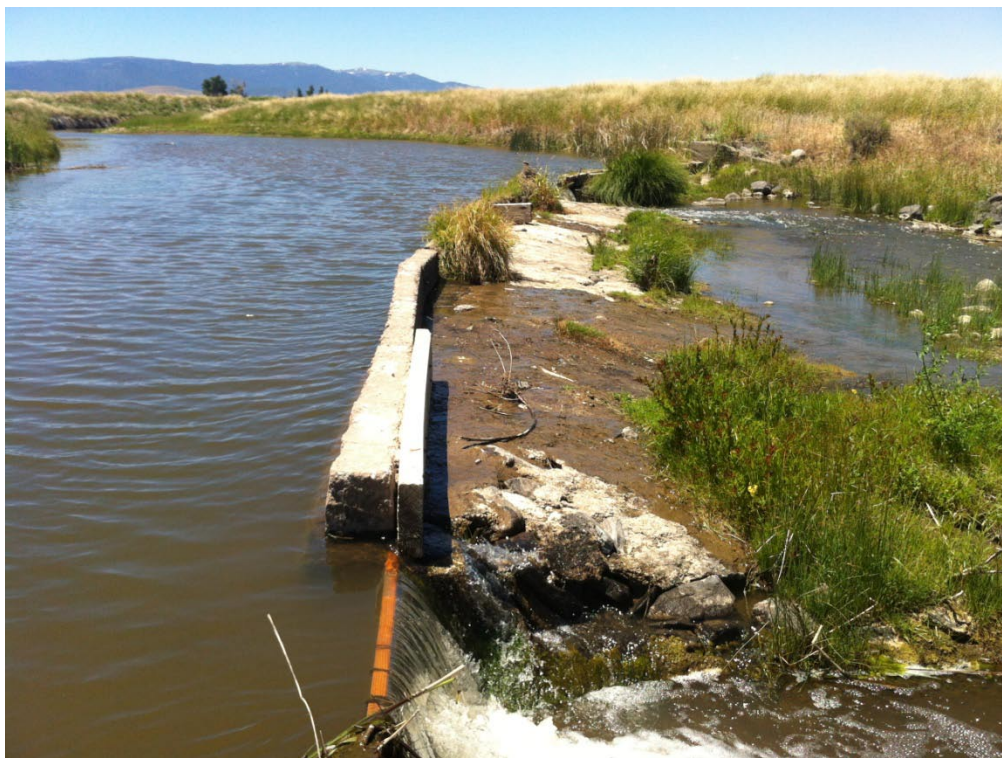
Figure 14: Charpontier Dam

Charpontier dam on the Susan River is a diversion structure that divides flows into Dill Slough and what is known as Tanner Slough (Susan River). This dam is basically a broad crested weir with two low flow channels that can be closed with flash boards. The dam spans the Susan River channel. The dam itself was most recently repaired in the 1980s through the addition of new concrete. During the site visit, many structural problems were observed. The original structure appears to have been a stone and mortar build with successive concrete layers added throughout the years. The mortar and concrete are both cracked, there are missing stones in the structure, and the broad crested weir is leaking in numerous spots at its base. Boils were observed on the high water apron in numerous locations. Holes within the spillway were observed and side cutting was noted on the south western wing wall. DEC recommends that Charpontier Dam be

restored to prior condition by replacing the existing structure. A new dam should be poured in the same location with wing walls extended further upstream. A larger cut off wall should be installed to reduce seepage and boils that are currently present. Instead of having two windows, a low flow channel shall be built and with the ability to place flashboards to control flow into Dill Slough. This low flow channel and addition of flashboards shall be rated for flow measurement. The weir portion of the dam should be uniformly poured and rated to provide useable flow measurement. A stilling basin with pressure transducers shall be installed with a radio SCADA unit for remote flow recording. The estimated cost to reconstruct Charpontier Dam is \$186,000, but shall be subject to change following further hydraulic and geotechnical analysis and verification of channel capacity.

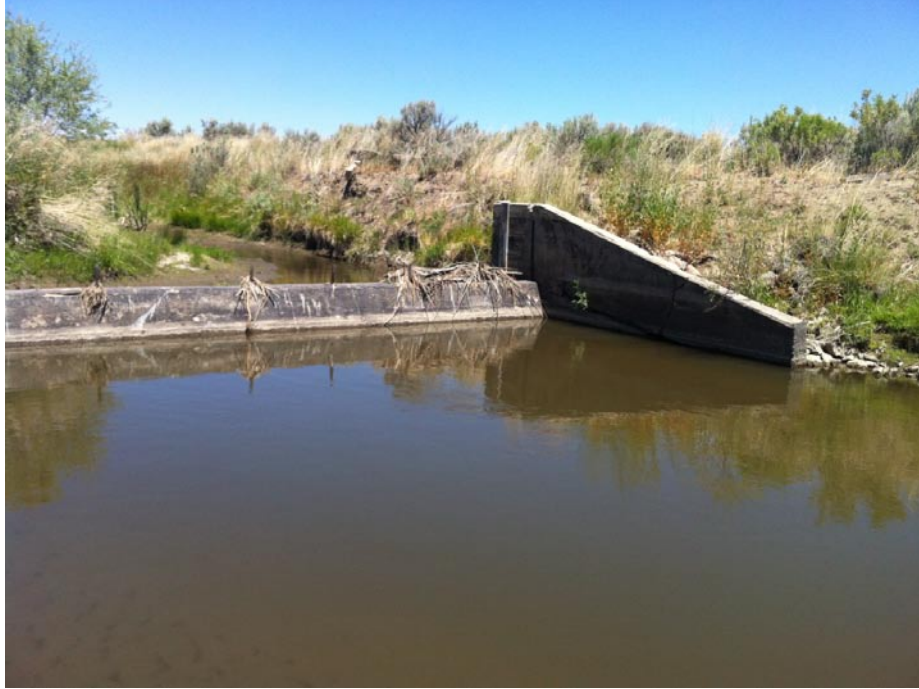
Figure 15: Window Dam

Window Dam is located downstream of Charpontier Dam on Dill Slough and was used as a means to store water within the slough's channel. The dam is a single span with a bottom opening "window". Historically, flash boards were used to control the river level. Water was intended to flow over the flashboards and in low flows and flushing situations, through the orifice at the bottom of the dam. This orifice was controlled by attaching a chain to a pneumatic device located on the south bank, over a pulley, then attached to a piece of plywood covering the opening. This required the water master to walk across the top of the flash boards and hook the

“shutter”. The pneumatic device has been nonfunctional for years now and the dam is no longer operable as originally intended. Therefore, water is no longer stored within this section of Dill Slough; at this point as the orifice remains opened. During field evaluations, the condition of the structure was analyzed and was determined to be in ill repair. The concrete on the wing walls exhibits significant cracking that is leading to movement between the two sections. The dam face was observed to have lateral stress fractures across the surface showing significant strain caused by uncontrolled flows. The uprights for flashboards are old pipes that have been shorn off to allow for access to the top of the dam and far bank. No concrete apron was present leading to erosion and undercutting of the dam during high flow events through the orifice and over the dam top. No flow measurement was present during the site visit. DEC recommends rebuilding the dam. New concrete shall be poured for the entire structure. The “window” should be replaced with dual weir gates. An apron poured of concrete should be poured in the spillway with appropriately sized energy dissipaters added at the end to reduce undercutting from dam flows. River flows should be recorded with a stilling basin outfitted with pressure transducers and connected to a radio SCADA unit for remote monitoring. Actuators could be added to the sluice gates to allow for remote management as well, but due to an increase in cost, and a non-necessary addition, this shall be left to the discretion of the irrigation district. Flows should no longer be managed in such a manner that overtopping of the dam is permissible. Providing storage at this structure would help better manage Susan River flooding events as high waters could be diverted at Charpontier Dam and stored at Window Dam for future use. The cost to rehabilitate Window Dam is \$83,000, but shall be subject to change following further hydraulic and geotechnical analysis and verification of channel capacity.

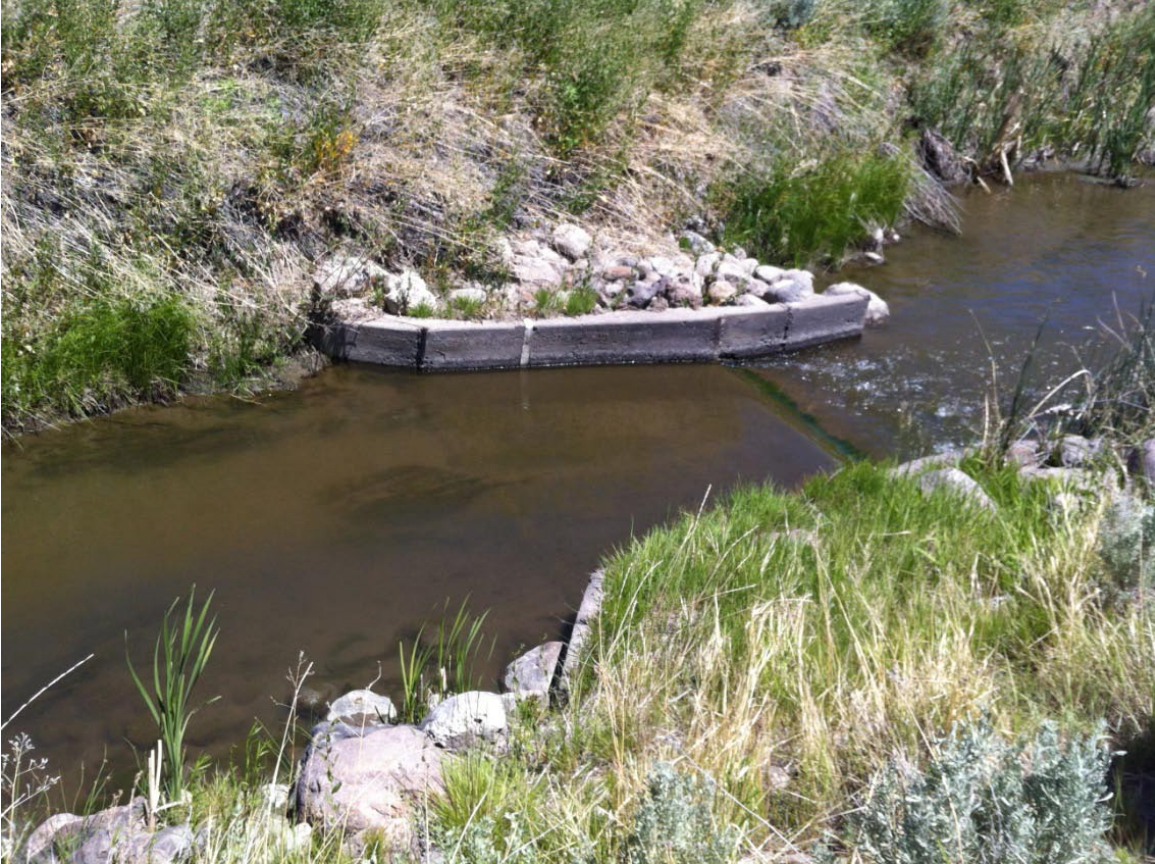
Figure 16: Virgil's Parshall

Virgil's Parshall is an 8 foot throated flow measuring device located on Dill Slough downstream of Window Dam. This is the first flow measurement device located on Dill Slough. The existing structure was deemed to be in moderate condition with minimal concrete damage observed. The device itself though was labeled as "unusable" by the water master during DEC's site work. Virgil's Parshall has settled within the slough and sits too low for most flow conditions. Total submergence during spring flows is consistently observed and standard flows generally exceed the normal depth range associated with an 8 foot throated Parshall. Accurate flow measurement is only available at the end of the irrigation season when flows are low enough to not need adjustment tables. DEC recommends replacing the existing structure with a new 10 foot Parshall for an increase in flow capabilities with care being taken to set the invert elevation higher in the channel to prevent excessive depths and submergence during high flow conditions. The flume shall be installed with a stilling well outfitted with pressure transducers which will be connected to a radio SCADA unit allowing for remote measurement. The engineers estimate to complete this project is \$55,000.

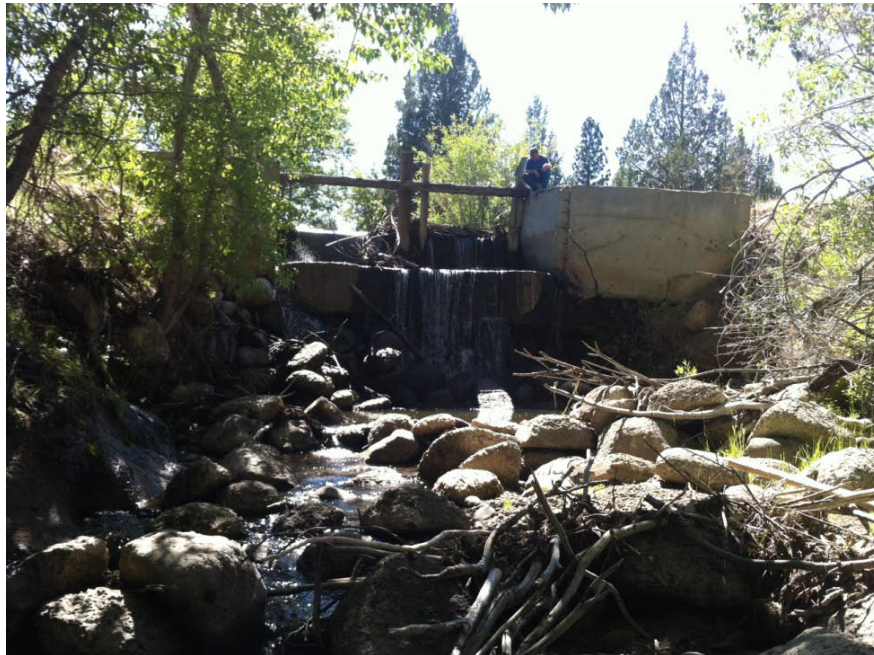
Figure 17: Gold Run Diversion

Gold Run Diversion is a dam located on Gold Run Creek that diverts water into a side channel for agricultural use. The condition of this dam is imminent failure. It is the opinion of DEC that this dam will fail in a high water event if not managed properly. This is the first diversion located on Gold Run Creek. The existing dam is a concrete structure outfitted with wooden uprights and flashboards for flow control. No flow measurement was present at the time of DEC's site assessment. From the upper creek bed, water flows experience two drops, the upper being a concrete apron and the lower drop is a rock lined channel. Concrete wing walls extend from the structure at an inadequate distance to prevent side cutting. From field analysis, the existing structure was found to be in critical condition. The north-western down-stream wing wall has separated at the joint and is held in place by the 8 rebar tensioning rods. The uprights rest on an old log. Boils were present downstream of the dam. The first drop, the concrete apron, was eroded away exposing the rebar mesh. Flows have eroded under the apron causing undercutting and stability issues. Debris has been used to back up flows into the diversion channel; flashboards having been washed away in prior storms were not replaced. The side buttresses are cracked diagonally throughout both structures, causing mild separation in these

walls. Hydrostatic and earth soil pressures have caused the entire structure to shift forward and lean over the existing creek. Soil erosion from high water flows and side cutting have exposed the foundation of the structure. DEC recommends that this structure be completely restored. New buttresses and wing walls shall be poured in place. The two drops shall be concrete with an exposed cut off wall poured between the two drops to prevent back cutting. The uprights shall be replaced with sluice gates for flow control to remove the need for flash boards. Actuators could be added to the sluice gates to allow for remote management as well, but due to an increase in cost, and a non-necessary addition, this shall be left to the discretion of the irrigation district. The dam shall be installed with a stilling well outfitted with pressure transducers which will be connected to a radio SCADA unit allowing for remote measurement. The engineers estimate to complete this project is \$87,000.
